US Army Corps
of Engineers

Construction Engineering
Research Laboratory

CERL Technical Report 99/54
June 1999

Potable Water Pipe Inspection at Westover Air Reserve Base, Chicopee, MA

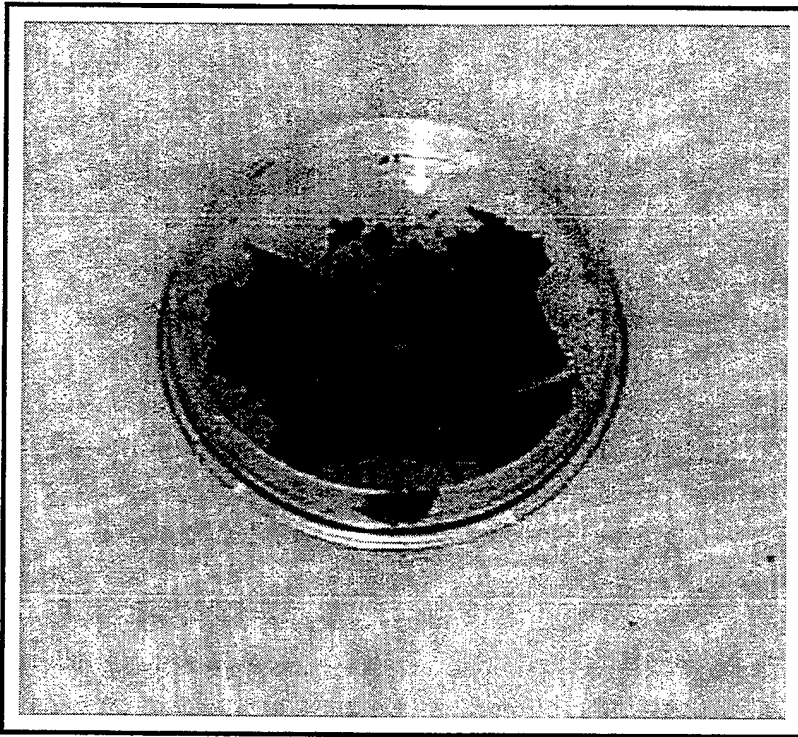
CERL investigators examined the coating materials in the petrie dishes. The material in the first petrie dish was soft and pliable, and appeared to be partially cured lining material (Figure 1). It was the same thickness and color as the inner lining material of the pipe previously examined. The several pieces stuck together and had to be pulled apart for examination. The material in the second petrie dish appeared to be fully cured (Figure 2). It was black in color with a thin, smooth layer of cementitious material on one side. A small portion of the inner coating material was removed for microscopic evaluation by chipping it off with a chisel and hammer. Examination of the coating pieces removed showed a much thicker layer of cementitious material, and a much rougher cementitious surface than the samples in the petrie dish.

Figure 1. Uncured coating recovered following flushing.

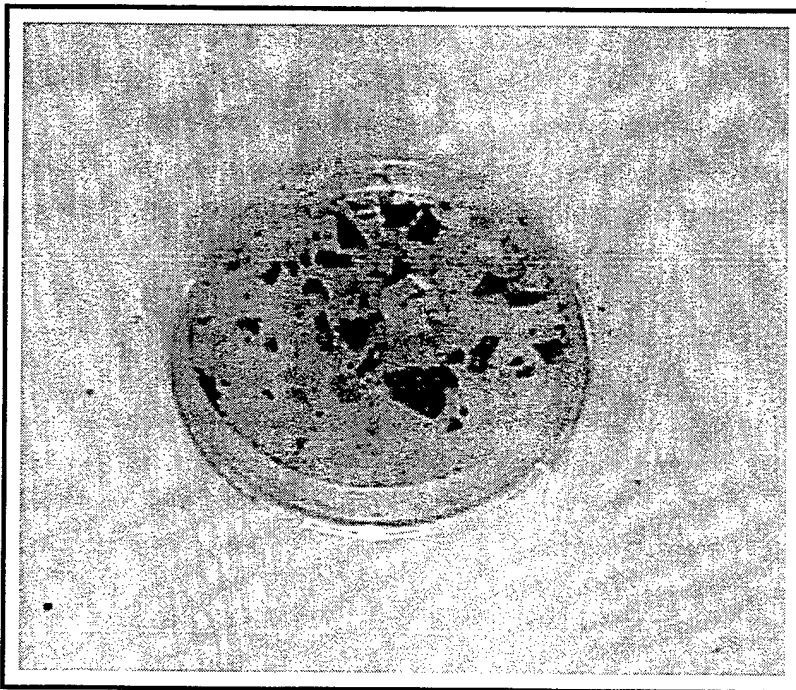
Figure 2. Cured coating recovered following flushing.

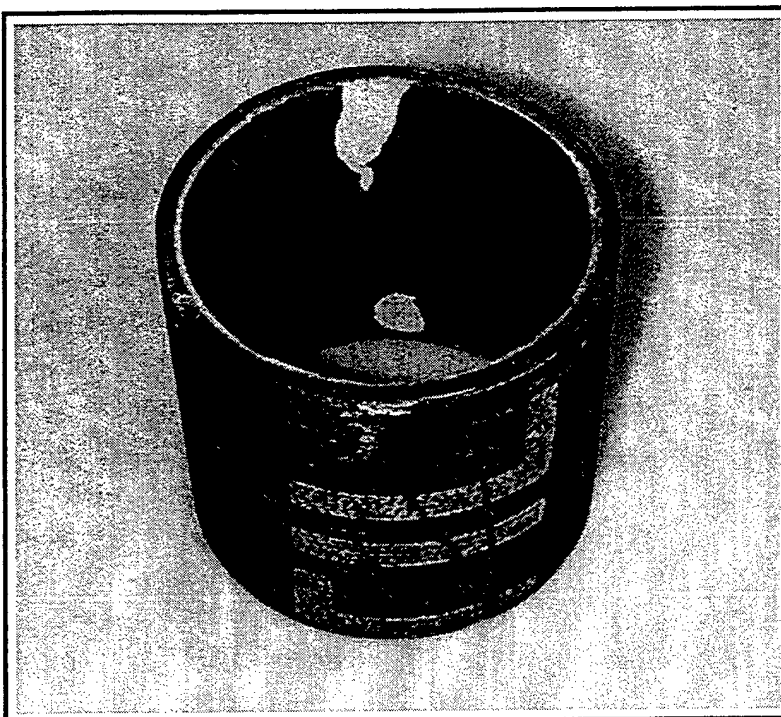
To evaluate the susceptibility of damage to the pipe lining due to sudden impact, the outside of the pipe was struck with a sledgehammer. A small portion of the inner liner popped off at the point of impact. The piece that popped off had the same thin coat of cementitious material on it as was seen on the sample in the second petrie dish. The cementitious material remaining on the inside of the pipe appeared unaffected (Figure 3). This indicates that sudden impact will cause the inner asphalt-epoxy liner to separate, leaving bare cement. The asphalt epoxy inner lining material from the pipe provided to CERL and the two different materials provided to CERL in the petrie dishes were also examined using scanning electron microscope elemental analysis. This analysis confirmed that all of the materials were also chemically the same.

Figure 3. Inside of pipe sample where struck with sledgehammer.
